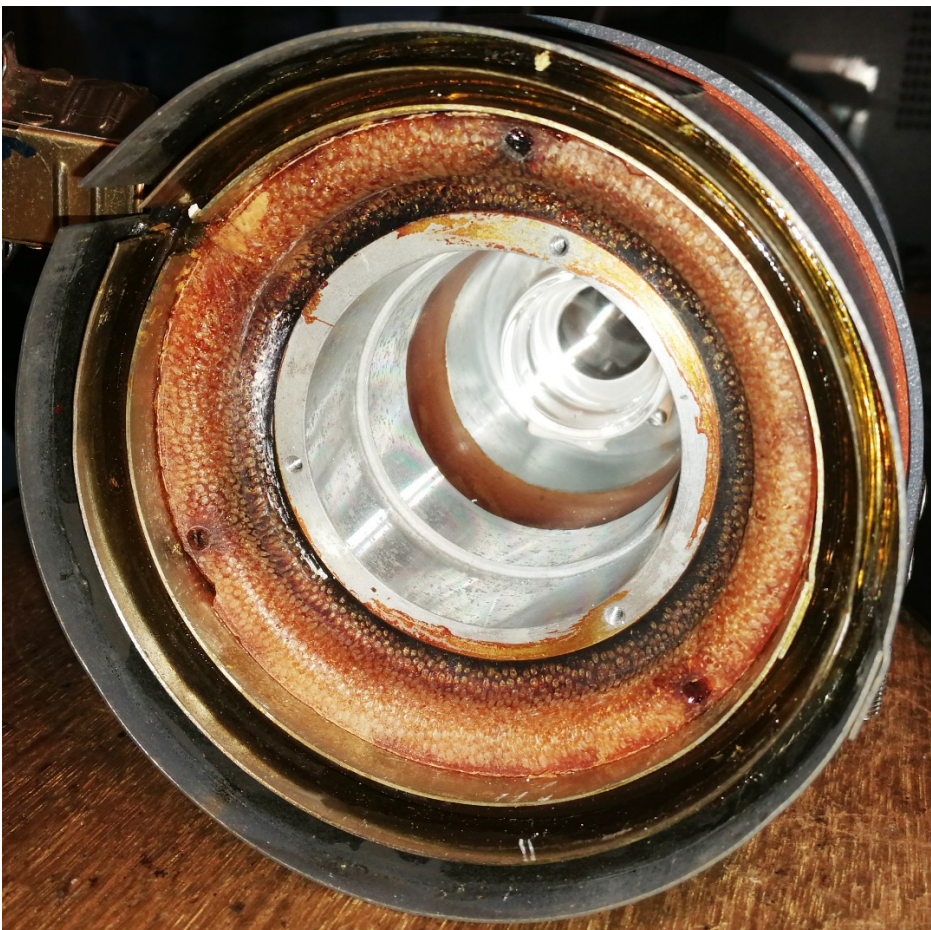
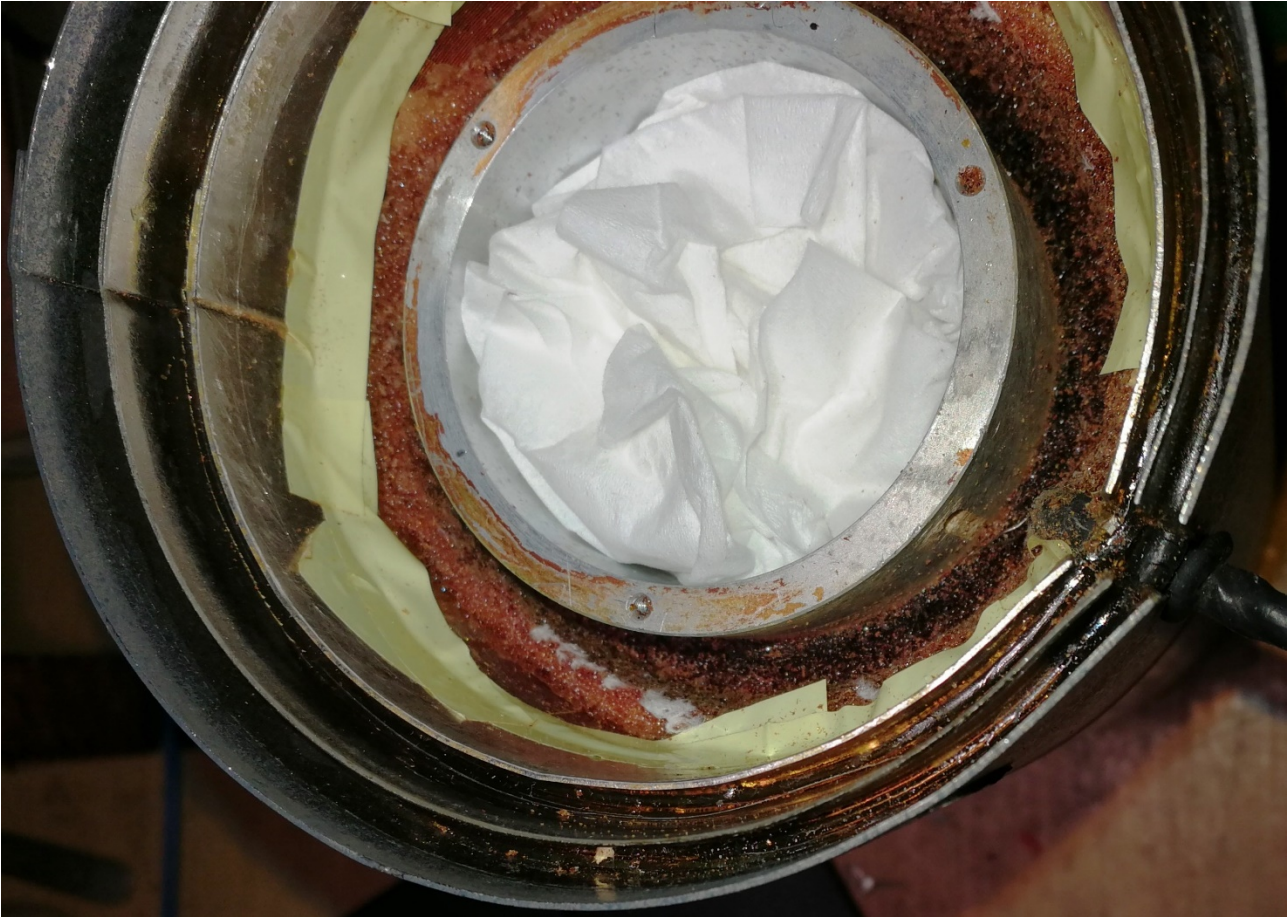
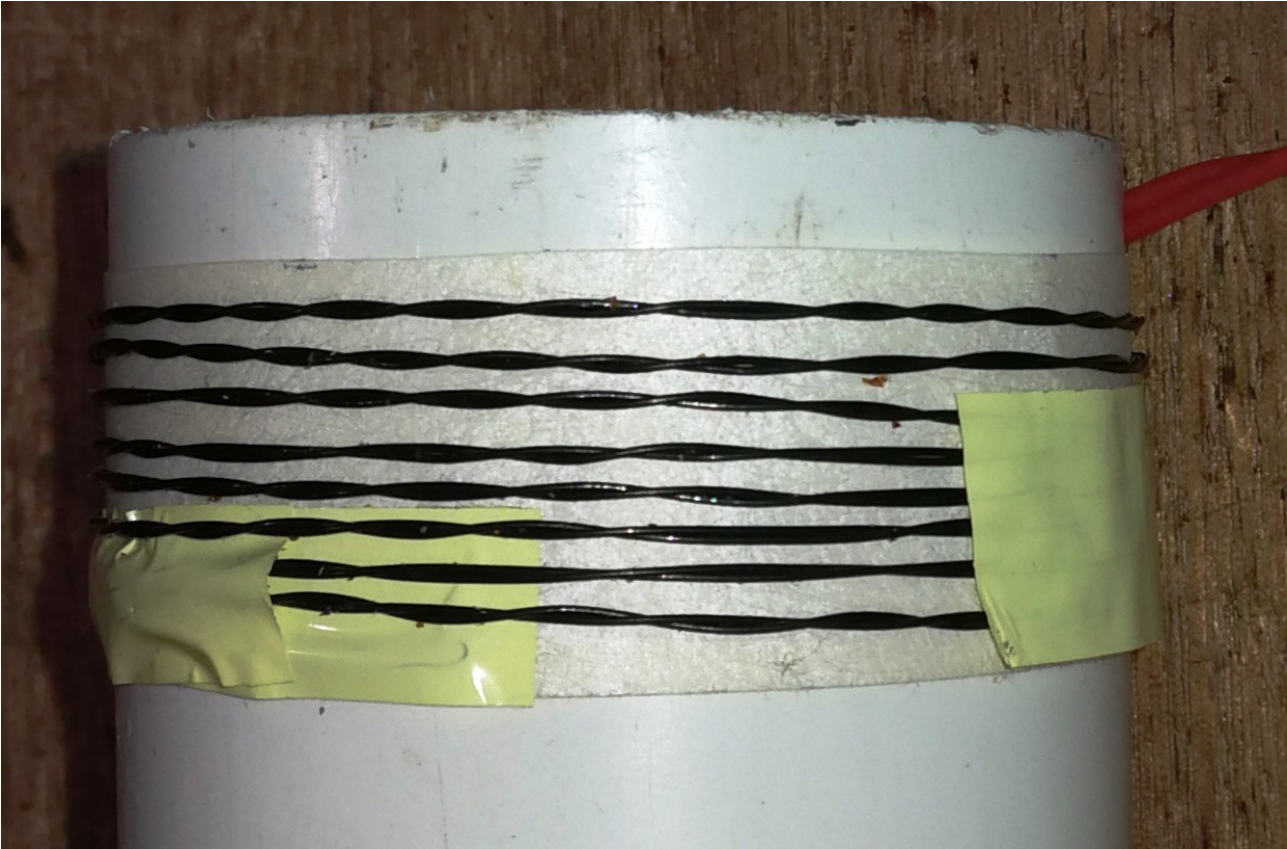
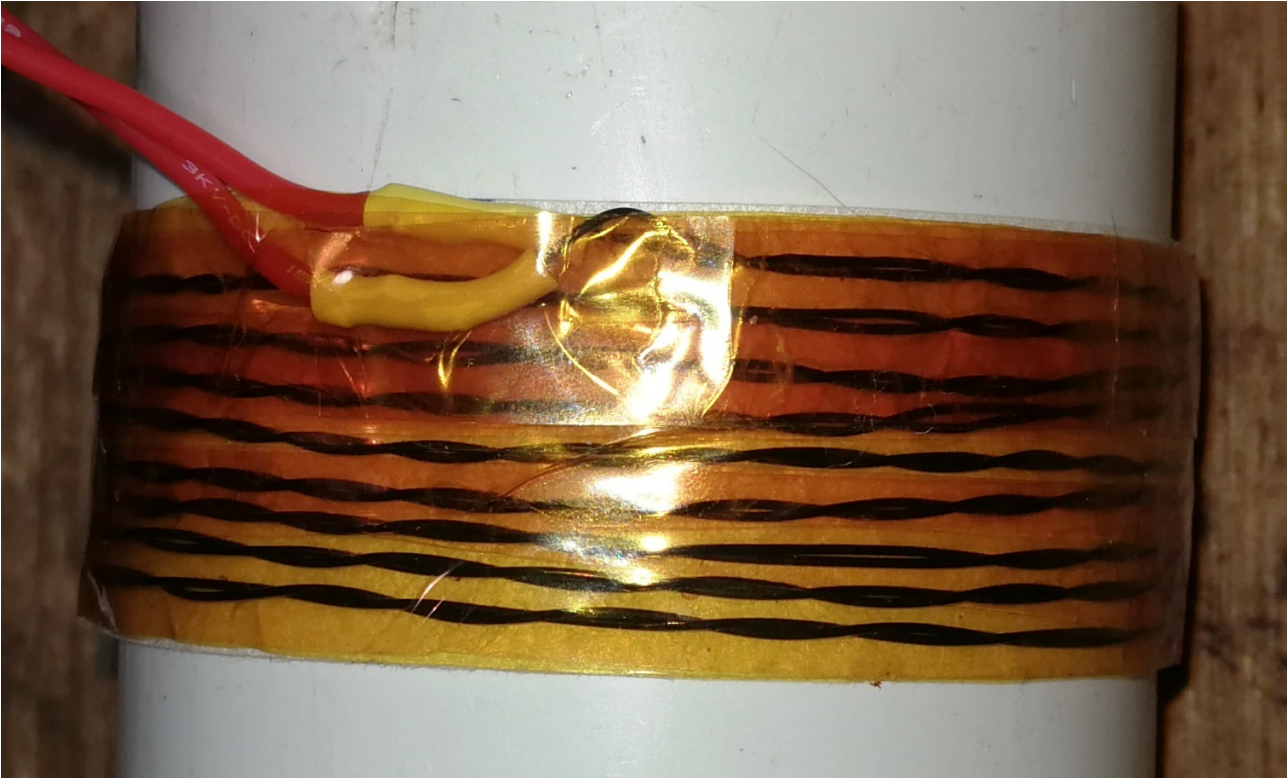
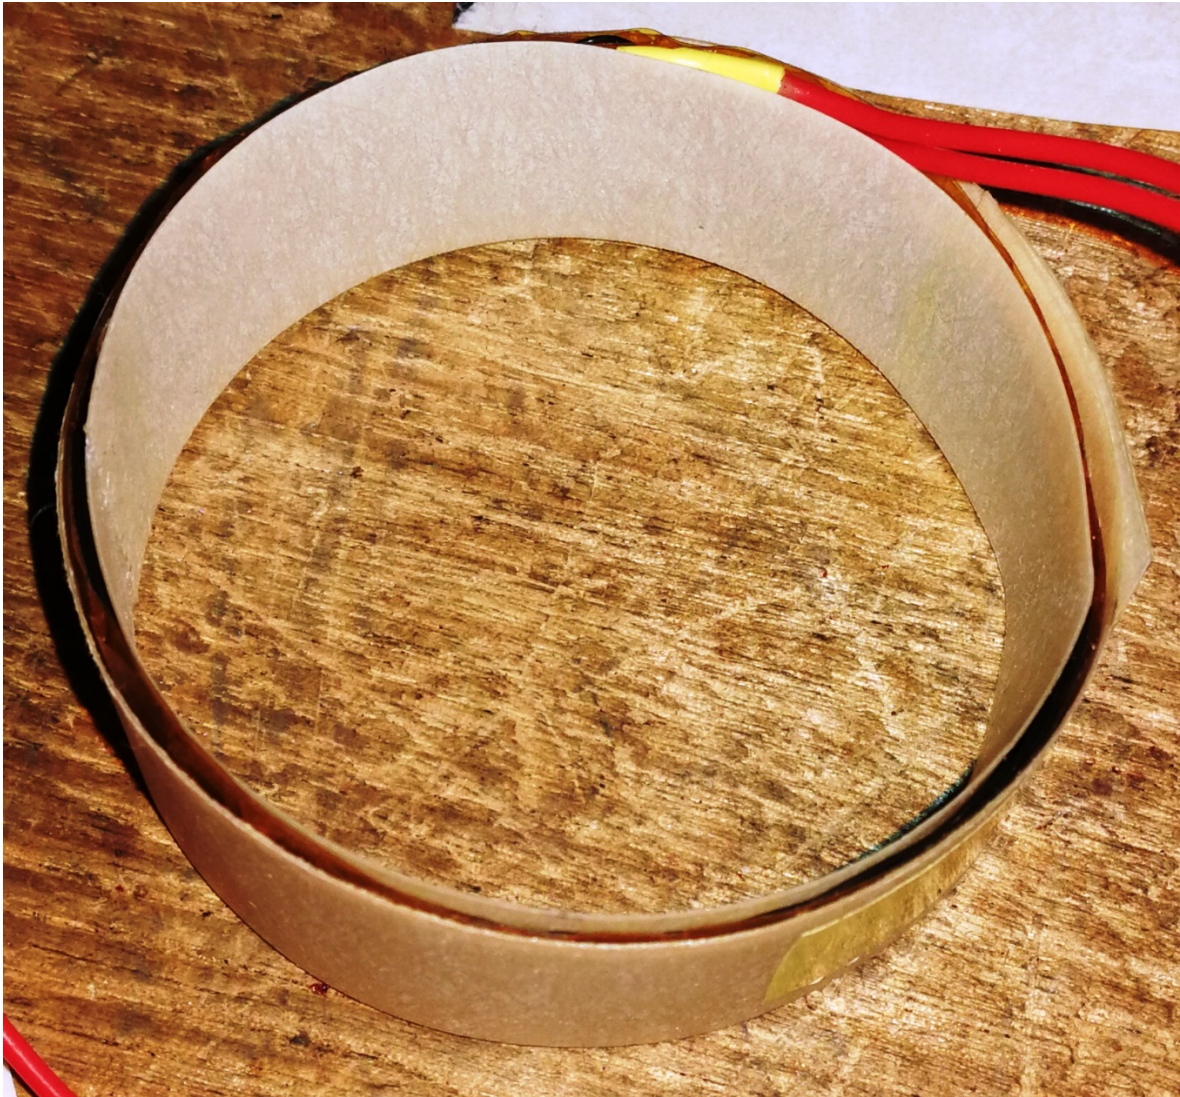
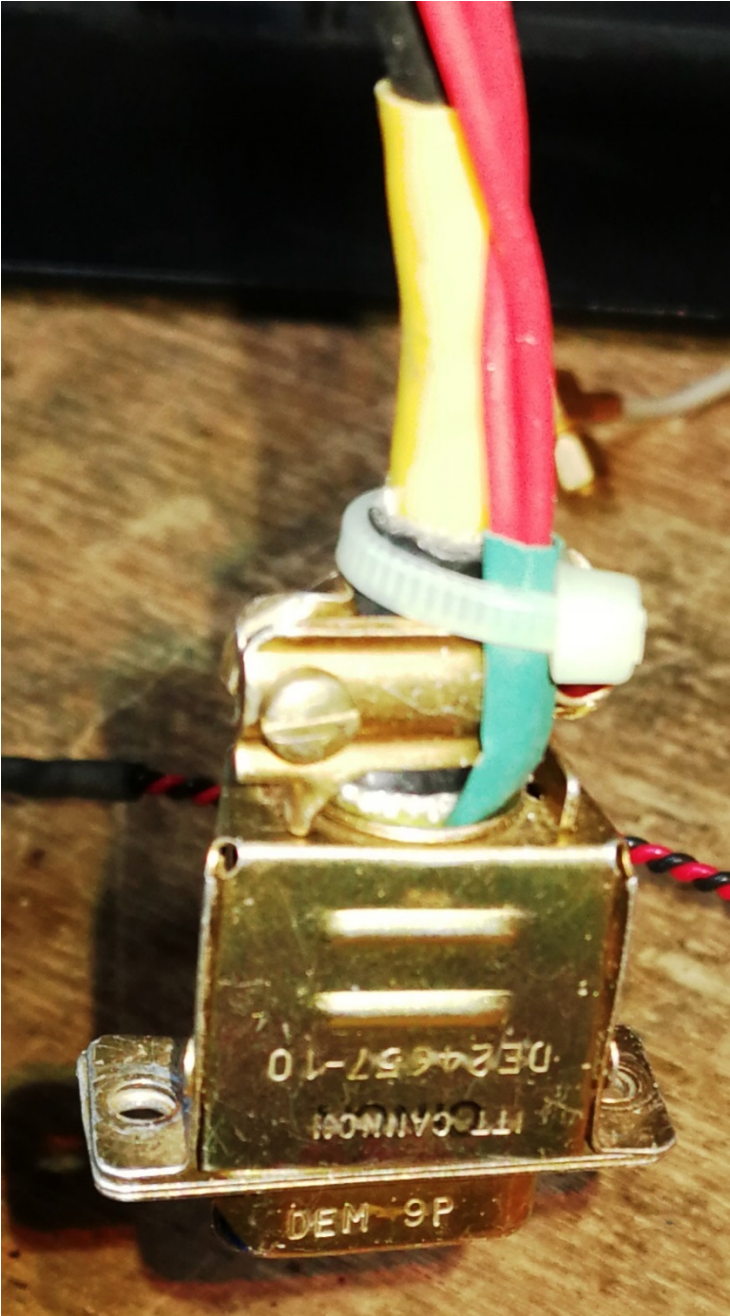
Original lamp heater was open-circuit, with pin 5 showing some resistance to ground. The foam insulation between lamp heater aluminium cylinder and housing was cooked, with the innermost annulus charred from the heater. A channel was carefully gouged around the perimeter of the aluminium cylinder with dimensions of about 6mm wide and 23mm deep. Total cylinder depth is 37mm, so cylinder was still 'locked' in position by the cooked foam. The machined groove in the cylinder became visible, but the thermistor was not visible and remained undisturbed. The DB9 cable remained in place and was sufficiently far from the cylinder wall to be a non-issue. A channel width of 6mm still allowed a good safety margin to the magnetic field coil located on the outermost inner surface of the housing (photos showed that I uncovered some of that coil, but the outer foam should be left undisturbed).

The resistance wire used was Pelican Teflon insulated advance wire type P2332ADVFEF.006BK, with a description of 32 AWG Solid (0.008"), Advance, 4.5938 Ohms/ft Nominal; 0.006" Black FEP Insulation; Nominal Finished Diameter 0.020". Total resistance was 54 ohm nominal. After folding and twisting, the wire was wound on to a nomex paper former made on a 60mm OD PVC pipe (DN50 pressure pipe in Australia), with about 8 turns splayed evenly. Each wire end was crimped to some thin silicone insulated wire using a short section of bootlace ferrule, and soldered and protected with some heatshrink. The coil was retained in place with multiple layers of Kapton self-adhesive tape, and then an over-wrap of nomex paper used to make an assembly that was relatively easy to slide into the gouged channel. Neoprene 3mm thick strip was used to retain the assembly in the channel and act as a thermal barrier, without the need for using RTV (and also make easier extraction if ever needed).

The in-situ heater was confirmed ok with a 20Vdc supply, and then the heater wires were terminated to the DB9 in lieu of the existing wires. With the DB9 only connected to the 5065A, the equipment was turned on and a K-type thermocouple stem was inserted into the lamp assembly sensing hole and the temperature confirmed to reach and regulate to about 92degC. The top covers were then reinstalled, and the whole assembly refitted.
