S.N. B010957. Opt A3 [Australian power option]. Servicing/repair notes Dec 2023.

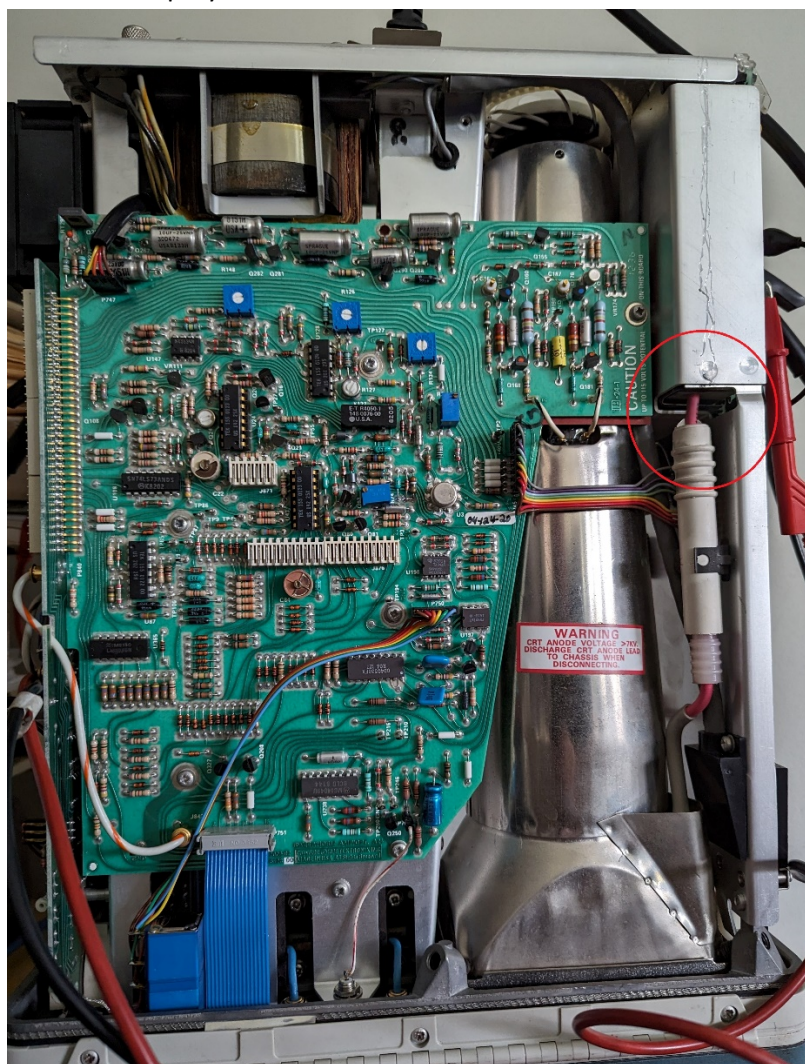
Removed all fuses. Reformed main large e-caps and confirmed leakage current at rated voltage was very low. Confirmed +40V supply rail energised via variac. Then confirmed +40V, +/-10V and +/-5V rails were good with their fuses in and using variac and using rail voltage test points. Re-fitted F89 and brought up on variac while monitoring 40V rail and +102V rail (TP320 on A15) and checking HV oscillator waveform '62' on TP161 to TP148. A spark was heard when variac approached mains voltage – sometimes no spark – spark located to between U130 HV module and in-line connector to tube anode. Perhaps some visible arc tracking visible where red insulated cable leaves the U130 module. Arcing plausibly due to age and fan induced dust ingress. Cleaned cable and tracking surface etc with IPA and then added nomex sheeting and heatshrink tubing sections to increase creepage and clearance from the anode lead to any nearby metalwork.

← Arcing region
