AC mains pre-heat winding had low insulation resistance to internal can, as did dc heater. Ribbon wiring between the two ends showed some wire-to-wire shorting. Internal can was completely excavated from housing for inspection. DC heater inspected and charred leakage paths to can removed or minimized. Ribbon wiring replaced with silicone insulated wiring. Failed parts on pcs identified and replaced. Charred/hard foam was removed as much as practical, but some portions retained to provide locations. Internal can refitted with neoprene strips used for thermal insulation to walls and nomex paper used to insulate ends and centre the can. Coarse frequency adjustment shaft had broken deep inside can – no fix, so workaround was to use heater temperature adjustment trimpot.

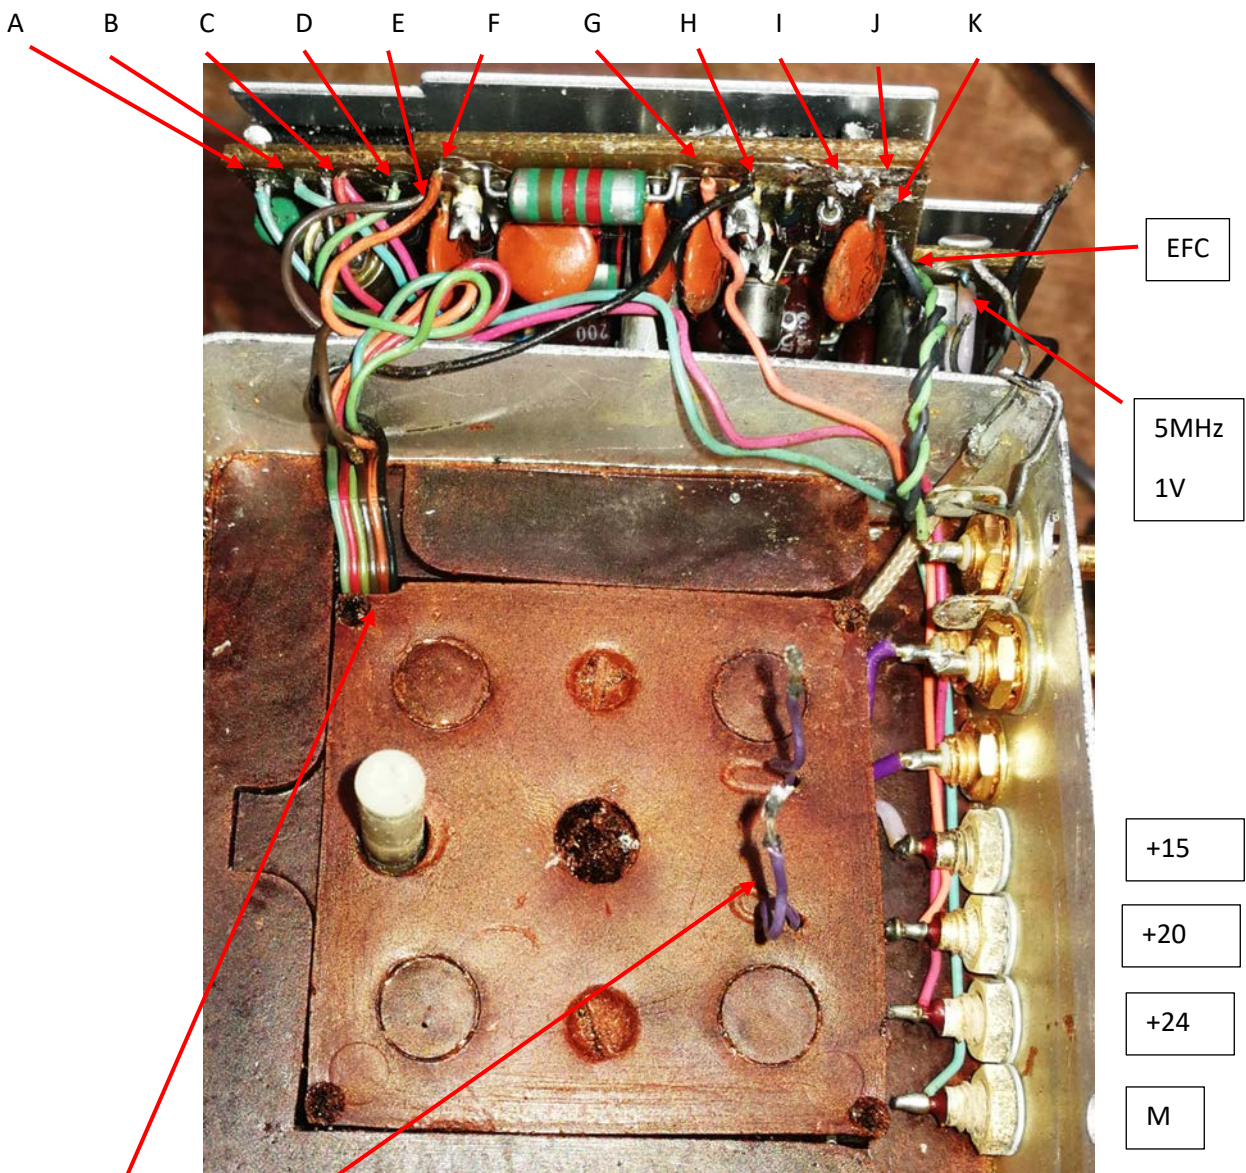
Terminal end pcb

Two purple wires from crystal embedded in central square foam.

Ribbon (black, orange, brown, green, red, blue) to other end pcb as well as internal DC heater.

Pcb circuit	Wire to ...	Note (* likely swapped)
A *	L3	Blue to ribbon to DC heater	Replaced by silicon red (4 bar)
B *	C4/Q3/Q4 node	Blue to M terminal	original
C	+24V star node	Red to +24 terminal Red to ribbon to other pcb F1 RHS	Replaced by silicon red Replaced by silicon black
D	Feedback to Q2	Green to ribbon to other pcb f/b CR2/C10

Pcb circuit	Wire to ...	Note (* likely swapped)
E	Feedback to 4R7	Brown to ribbon to other pcb f/b CR1/C10	
F	L1/R1/R5/C11	Orange to ribbon to other pcb C9/R11	Incorrect on schematic Replaced by silicon red
G	L1	Orange to +20 terminal	
H	Gnd near DIV	Black to ribbon to other pcb gnd	Pcb trace with 3 gnds
I	Gnd near DIV	TCW to DIV socket lug	Pcb trace with 3 gnds
J	Gnd near DIV	Coax sheath to 5MHz can feedthrough	Pcb trace with 3 gnds
K	C1 then R1	Coax core to 5MHz can feedthrough	
DIV (J4)	C6/C8 gnd	Signal to light green to terminal end pcb Shield to dark green to terminal end pcb	
1V		Signal insulated to terminal end pcb Shield TCW to terminal end pcb	
-EFC		R1 (10kΩ) to can	
+EFC		R2 (10kΩ) to can	
+15		L2 (220uH) to can	
+20		Orange to terminal end pcb L1 (220uH) to can	
+24		Red to terminal end pcb	
M		Blue to terminal end PCB	
	CR2 gnd	Black to 5MHz/1V shield lug

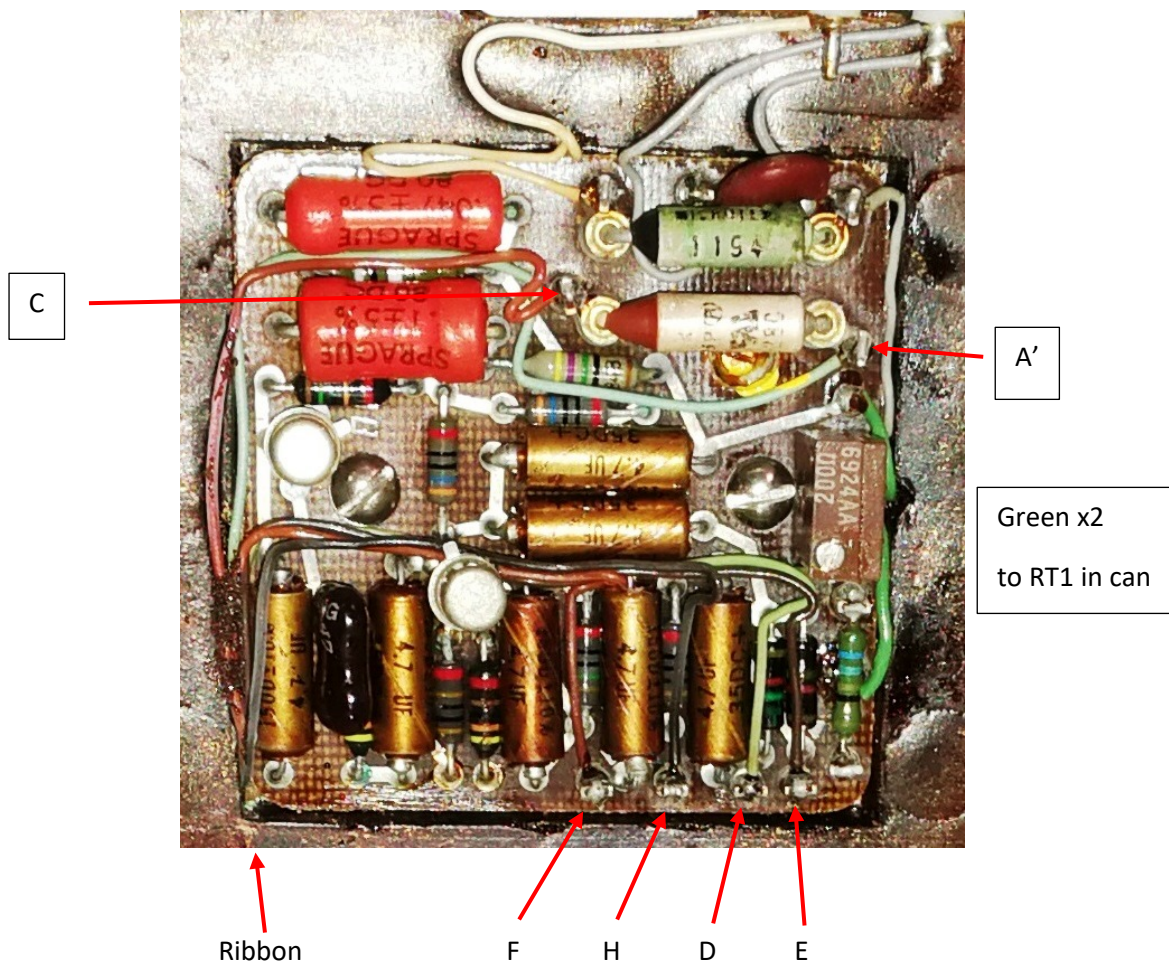
AC heater end pcb

AC wiring to AC terminals and AC heater and pcb F2/C11 disconnected.

Pcb circuit	Wire to ...	Note
A'	F1 LHS	Blue to ribbon to DC heater	Now to F1 RHS
C	F1 RHS	Red to ribbon to other pcb +24V star	Now to F1 LHS Replaced by silicon black
D	CR2/C10	Green to ribbon to other pcb feedback Q2	Replaced by silicon red (1 bar)
E	CR1/C10	Brown to ribbon to other pcb feedback 4R7	Replaced by silicon red (2 bar)
F	C9/R11	Orange to ribbon to other pcb +20V	Replaced by silicon red (3 bar)
H	gnd	Black to ribbon to other pcb gnd

Note that heater can connect to F1 at either end to suit wiring.

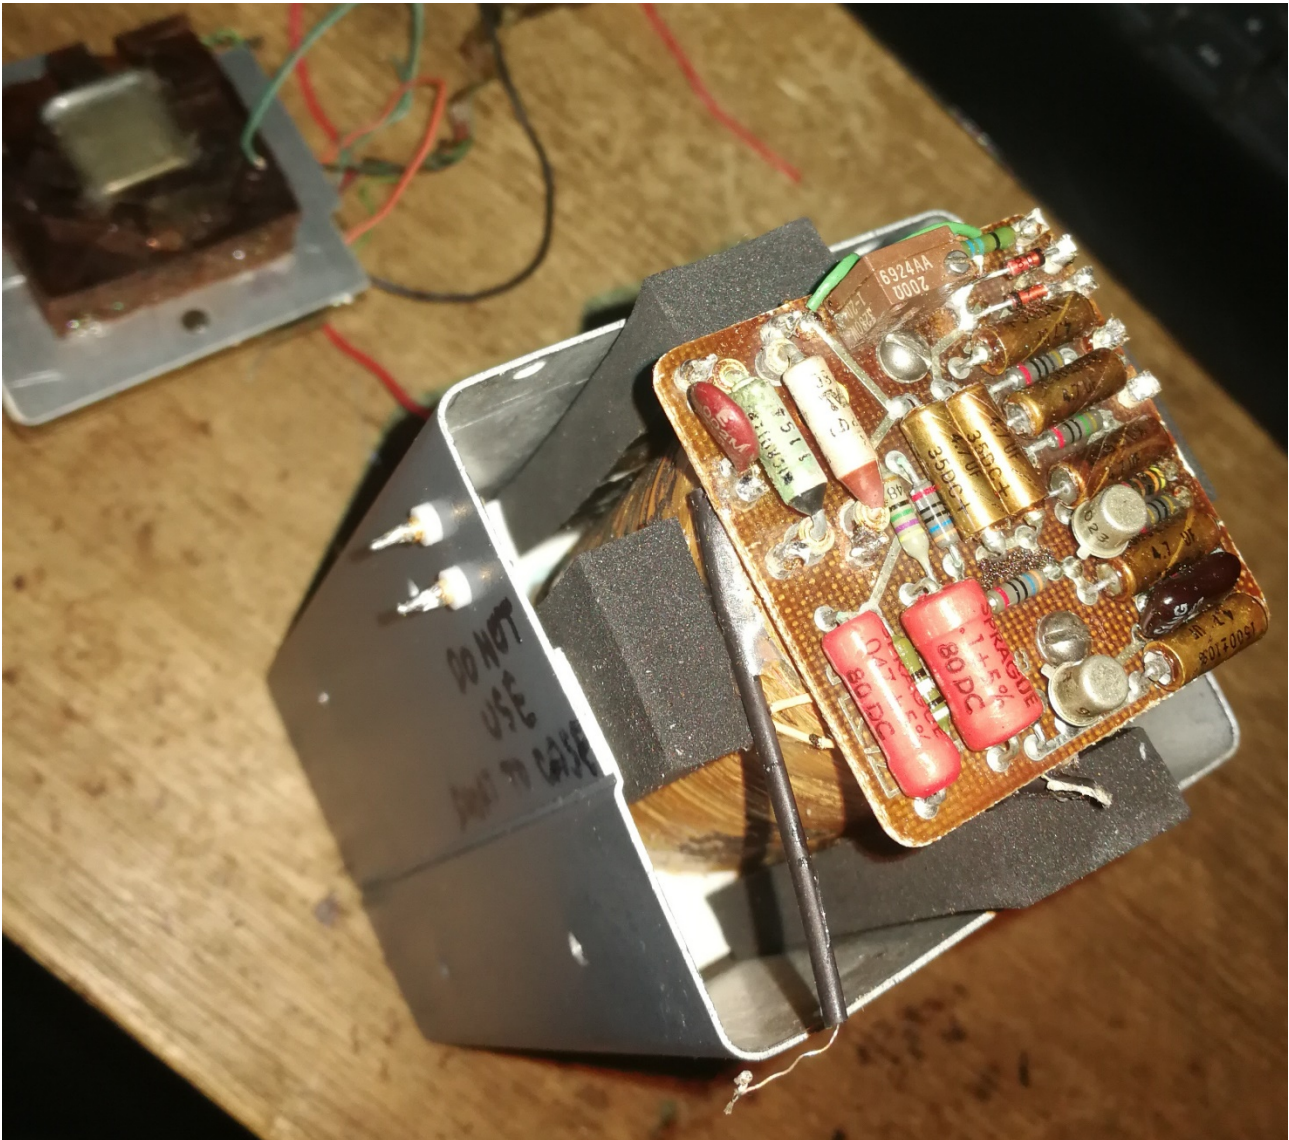
Additional neoprene strips used to fill cavity once in-situ and correctly located for end-caps.
